Steve Ramsey, TREC # 20497

# PROPERTY INSPECTION REPORT FORM

Sample	date
Name of Client	Date of Inspection
Address	
Address of Inspected Property	
Steve E Ramsey	20497
Name of Inspector	TREC License #

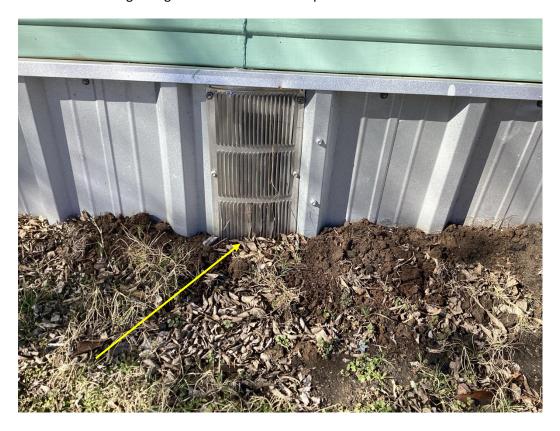
- The foundation appears to be performing overall.
- The vents are placed vertically instead of horizontally as they were designed for. Also, some of these are right at grade so that the soil is up to or above the vents.

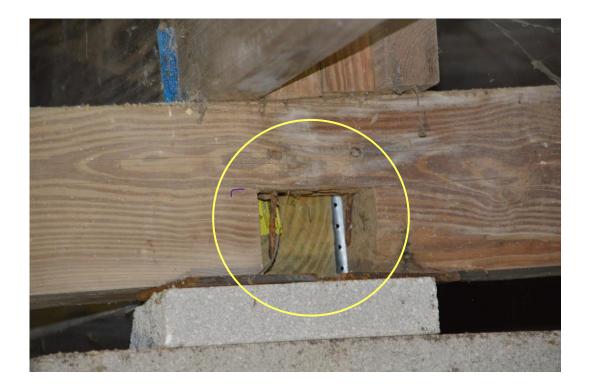
• There were a couple of the original beams that had significant notches in them that were about half their total depth. The notches should be less than 1/6 the depth of the board.

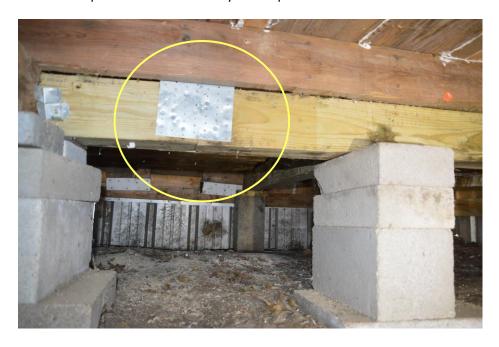
• There were splices in several of the beams. These were not strengthened correctly (held with construction screws and sheet metal) and did not have support under them as there should. All splices should be directly over a pier.

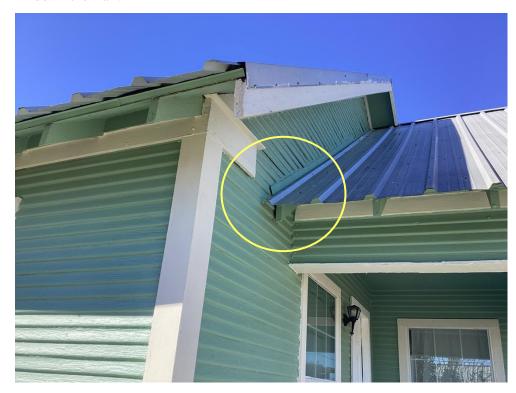
There should be kickout flashing where the roof meets a wall of the house at the back bathroom and front porch areas. This is to protect against water running off the roof and down the wall.

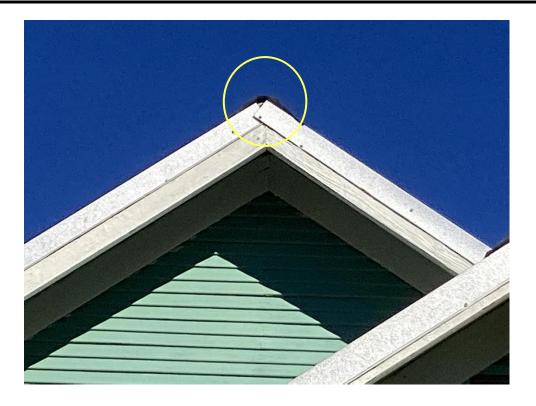
There was a gap in the rake at the peak of the gable upper gable at the back of the house.

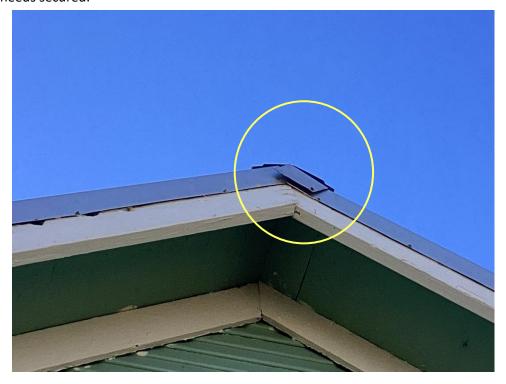
There was a small piece of the rake at the front peak of the cable that was loose. This
needs secured.

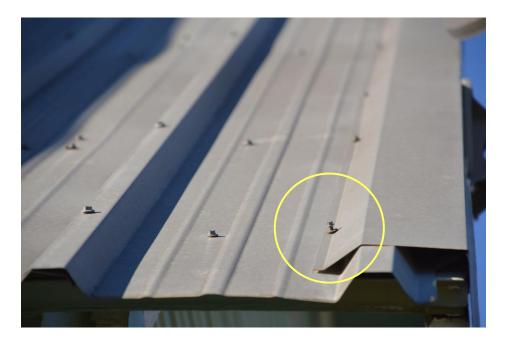
• There's a loose screw the front left corner lines installed.

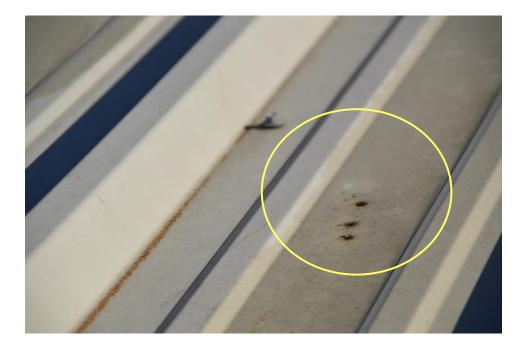
• There were some holes in the metal above the addition at the right side of the house that need repaired or replaced.

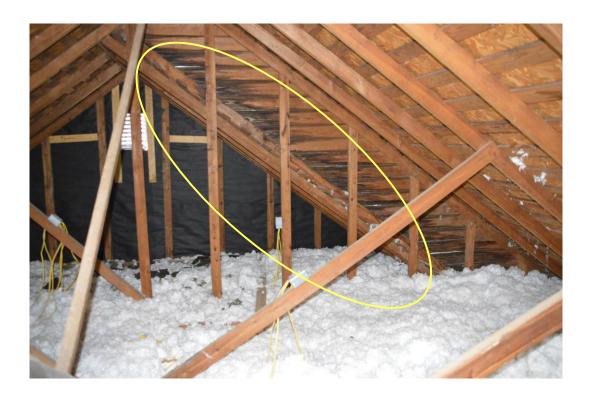
There was some evidence of water penetration along the roof at the front porch where it joins the main part of the house. This should have the correct flashing to protect against this.

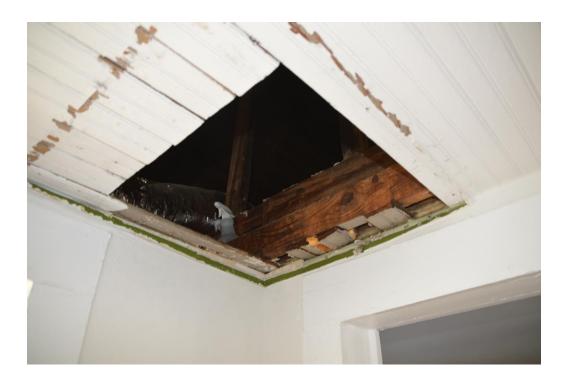
The access hole was too small. This should be at least 22x30 inches. It should be large enough to allow for removal of the HVAC unit.

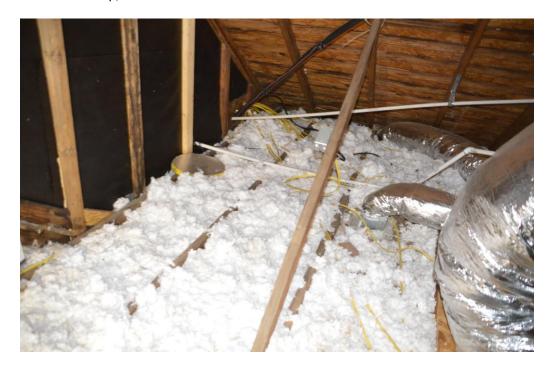
• The amount of insulation was significantly lower than current standards. This was about 2-3 inches deep, whereas new houses have 12-16 inches.

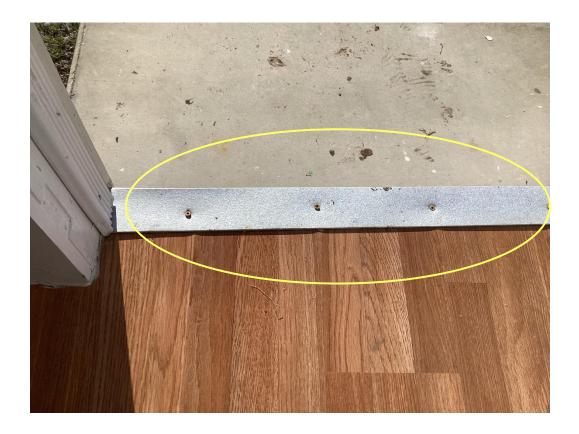
• There were screws along the metal at the back door threshold. These will probably leak and cause problems such as rust. This is especially a concern because there's no overhead roof above the back door to deflect rain.

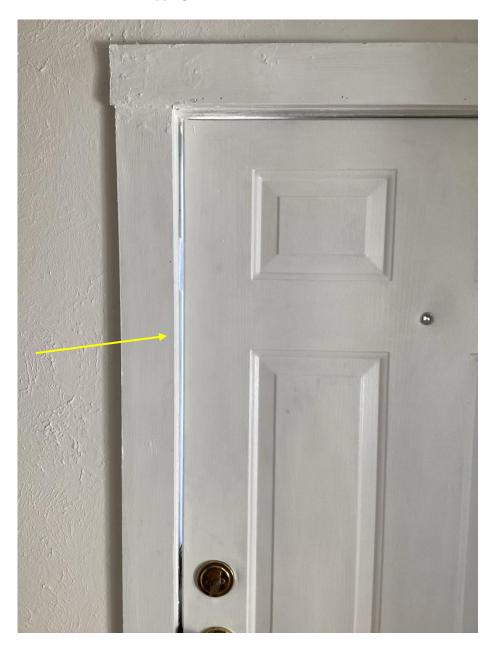
• The back door does not seal along the outside and top of the door. This should have weatherstripping added.

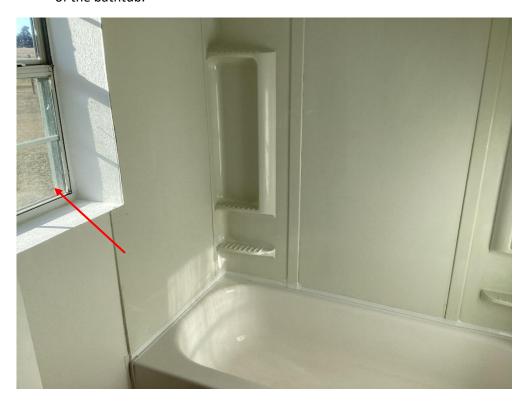
- Several screens were missing from the windows.
- There was a torn screen at the front bedroom.
- The windows at both bathrooms should be tempered safety glass because it's within 5 feet of the bathtub.

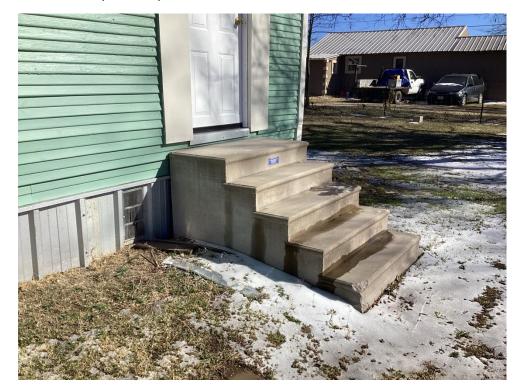
• The back porch steps need a handrail.

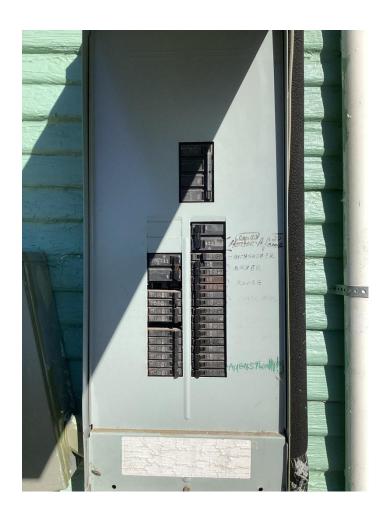
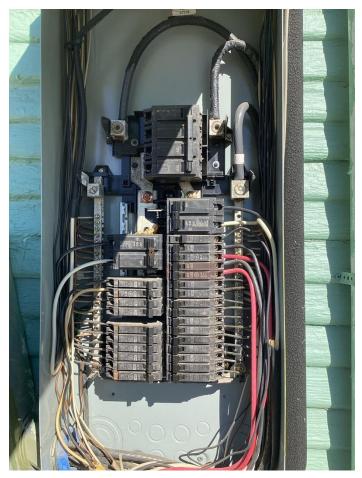
- There was an underground 200 amp service to the house. The service panel is located at the back exterior wall.
- There was a ground wire to the panel but I could not locate the ground rod. The wire goes into the ground and then disappears.
- There were some open twist outs on the dead front cover panel. They should have cover plates installed for safety.
- All breaker should be labeled clearly but only some were.
- The white wires being used as hot should be marked hot with something such as black electrical tape.
- One of the breakers for the dishwasher was turned off.

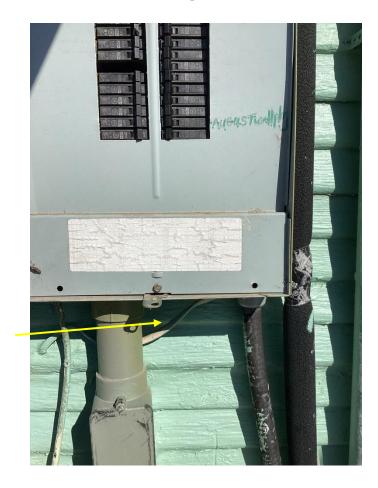
- All outlets along the kitchen counter and in the mudroom should be GFCI protected.
- Arc fault circuit interrupters (AFCI) are required for all receptacles in kitchens, family rooms, dining rooms, living rooms, parlors, libraries, dens, bedrooms, sunrooms, recreation rooms, closets, hallways, and laundry areas
- Receptacles less than five and a half feet above the floor are required to be tamper resistant
- Smoke detectors are required in each sleeping room, outside each separate sleeping area, in the immediate vicinity of the sleeping rooms, and in the living space of each story of the dwelling.
- There were some exposed wires at the exterior at the floodlights at the front and the back as well as below the electrical panel. These should be in conduit.

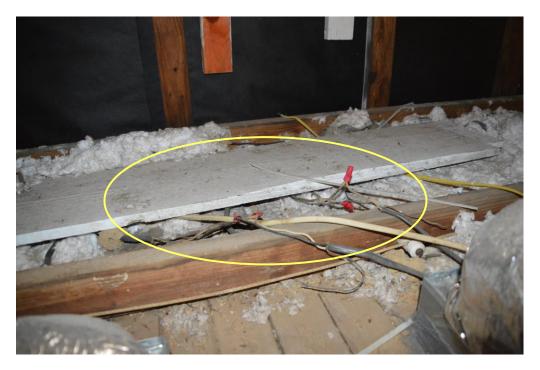
There were a couple of open junctions above the mudroom area and the back bathroom. They should be in junction boxes.

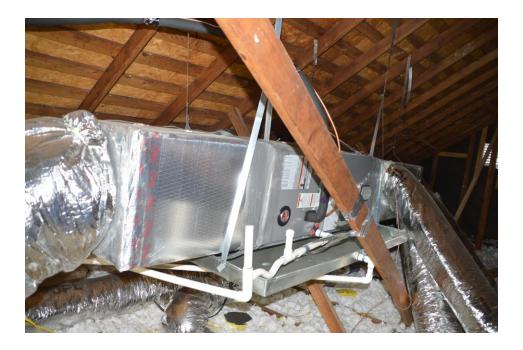
- This was a heat pump system so it has two heating modes.
- It was operating fine in both modes, with emergency heat blowing out around 95° and heat blowing out around 124°.
- There should be a walkway and a working platform in front of the unit in the attic.

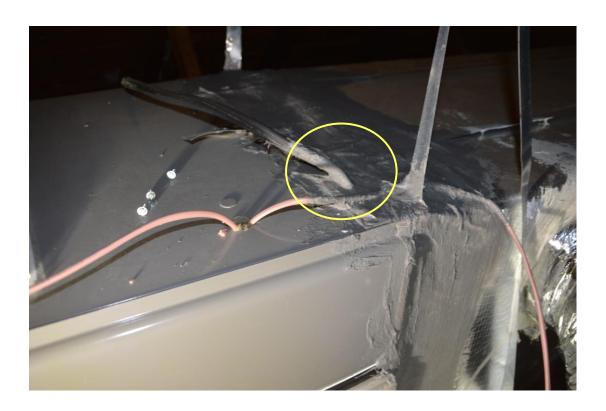
• Where the wires enter the top of the unit in the attic, there should be a grommet or clamp holding them.

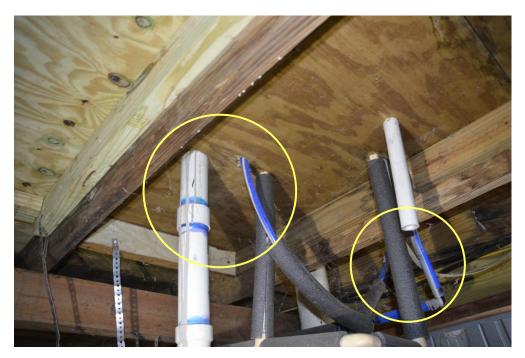
- There should be an anti-siphon valve on every exterior faucet.
- The water pressure was 36 psi which is a little low. Normally this should be at least 40 psi.
- There were several places under the house where the waterlines were not insulated as they should be.

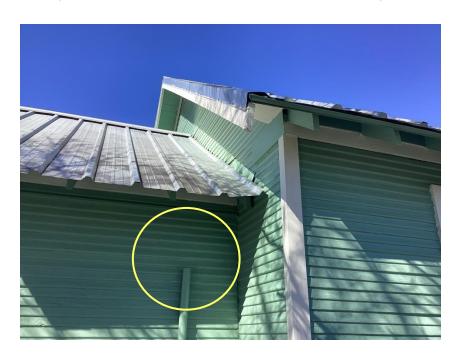
• The drain vents the back left corner and at the back near the electrical panel need to extend vertically because there are windows within 10 feet horizontally.

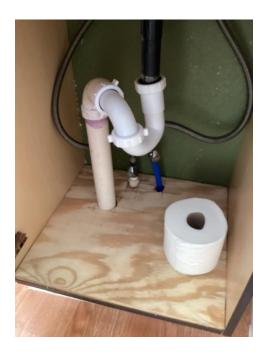
• There were S traps under the kitchen sink and the back bathroom sink. S traps are not allowed because they can siphon the water out of the trap which allows in sewer gases.

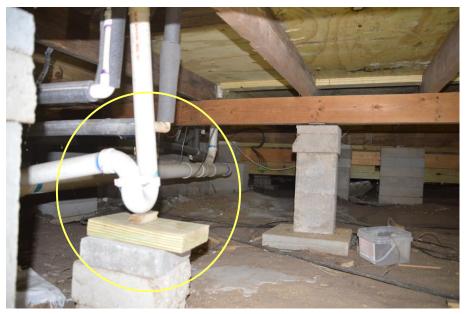
• Some of the drain lines were not correctly supported as they should be. They were missing straps and at least one under the back bathroom had blocks under it rather than straps.

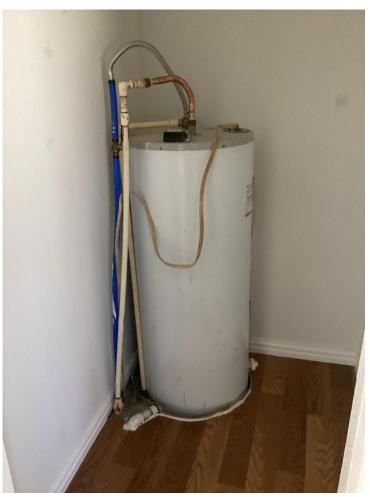
• The electrical wire should be in armored cable.

• There was a pan but it appears that it drains directly under the house. This should drain to the exterior of the house.

• Also, the pan needs to be cleaned out.

• The TPR drains into the pan but should be cut off to where it's not in the pan but ends above the lip of the pan.

• There should be an electrical disconnect at the heater.

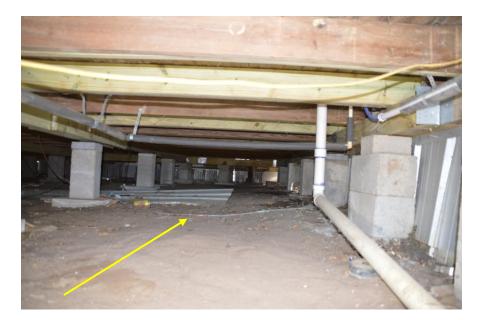
• They did not appear to be gas to the house during the inspection. There was a gas wall heater in the living room and there was a gas line under the house that went out under the skirting to the left of the house. There was no evidence of a gas tank or meter of any sort.

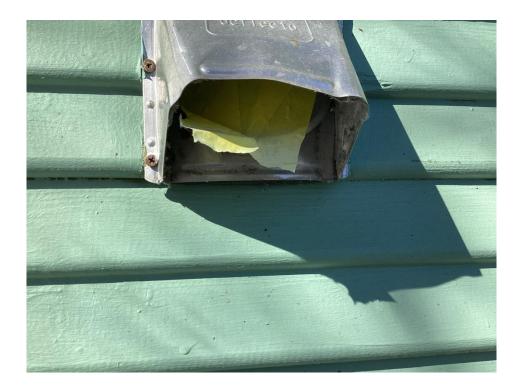
• This had some masking tape on it that needs to be removed. Also, the damper was partially open and should be repaired so that it closes when not in use.
