# Home Inspection Report

October 11, 2021

**Steve Ramsey Home Inspections**

# Pre-Drywall Inspection Report

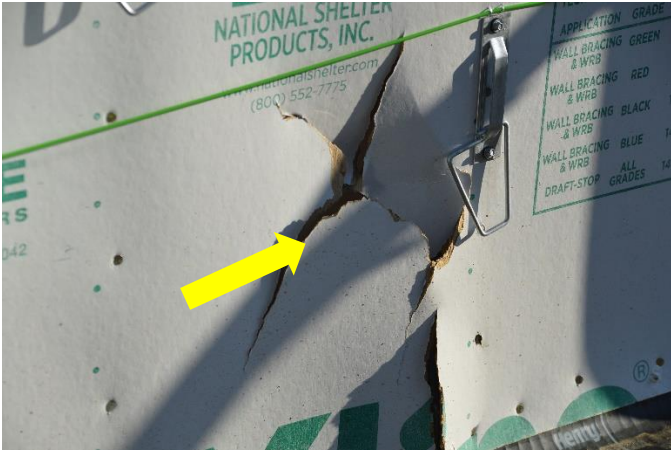
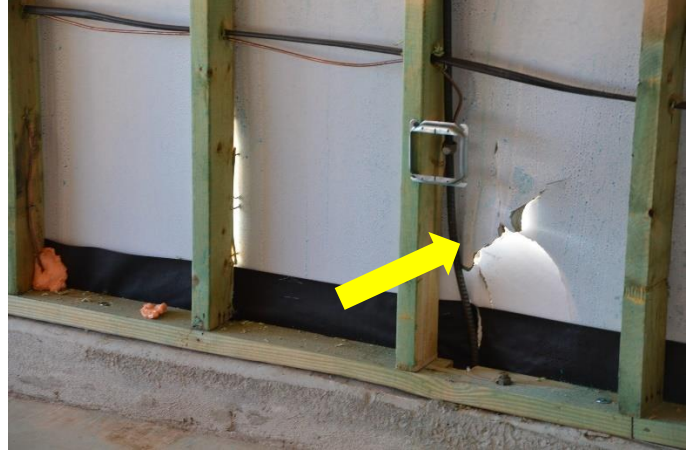
**A. Exterior Walls**

1. The sheathing at the left side of the garage was damaged. This should be repaired or replaced.

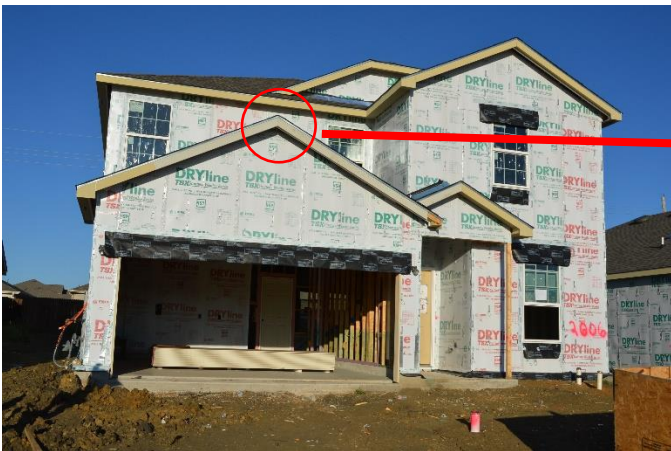
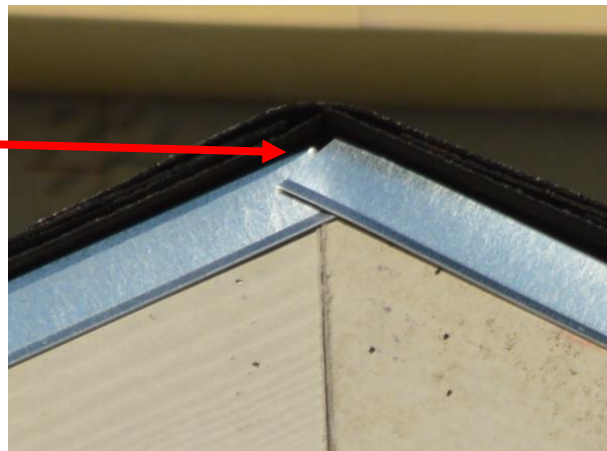
**B. Roof Covering (exterior)**

1. There was a small gap at the drip edge flashing at the roof peak above the garage door. This could allow in rain and should overlap completely.

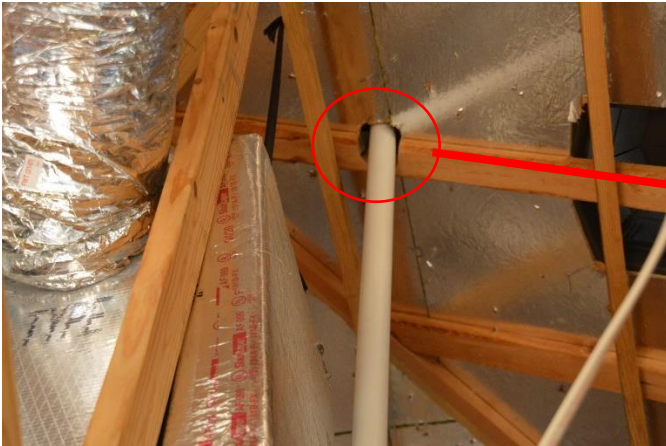
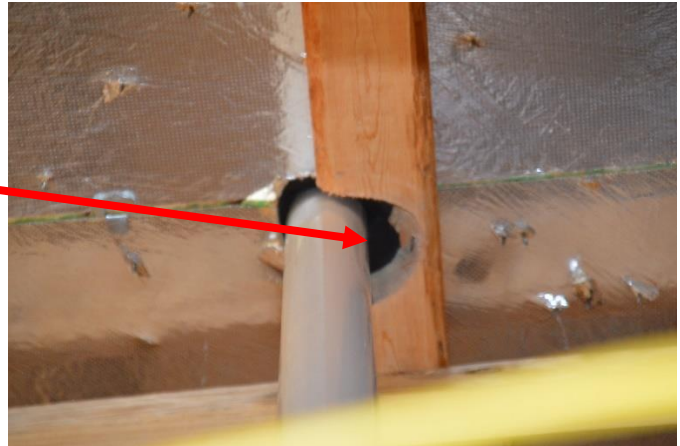
**C. Roof Interior (attic)**

1. Above the upstairs guest bathroom, there was a support between trusses that has been almost cut in two to allow for the plumbing drain vent pipe. This board should be repaired or replaced.

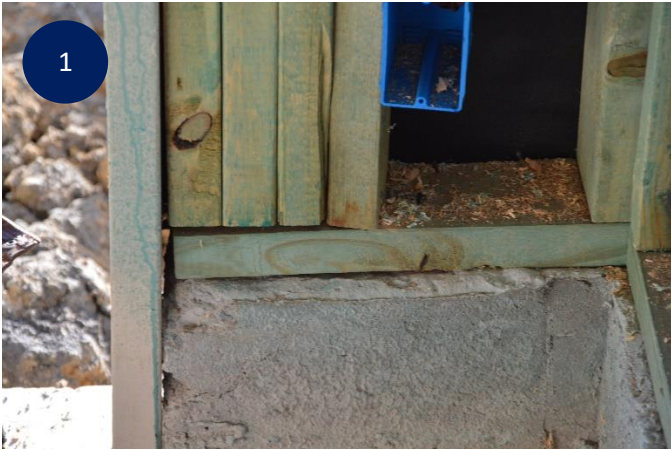
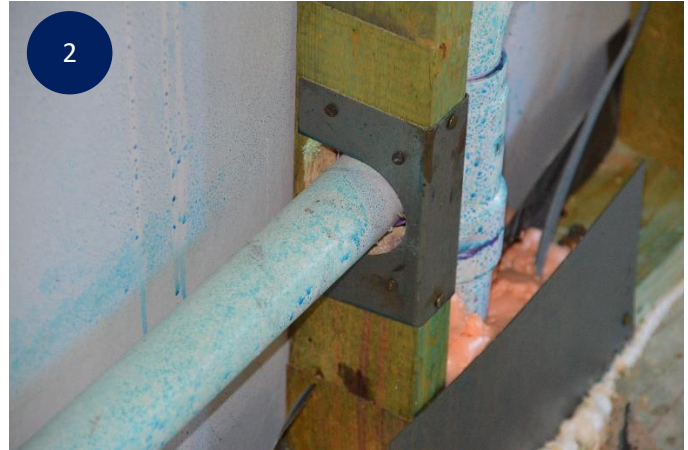
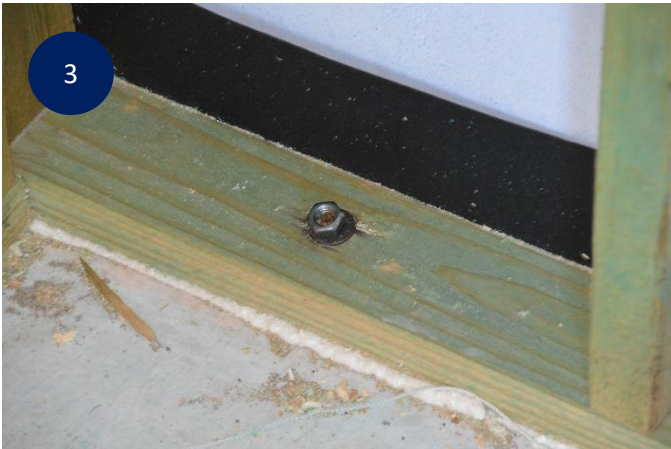
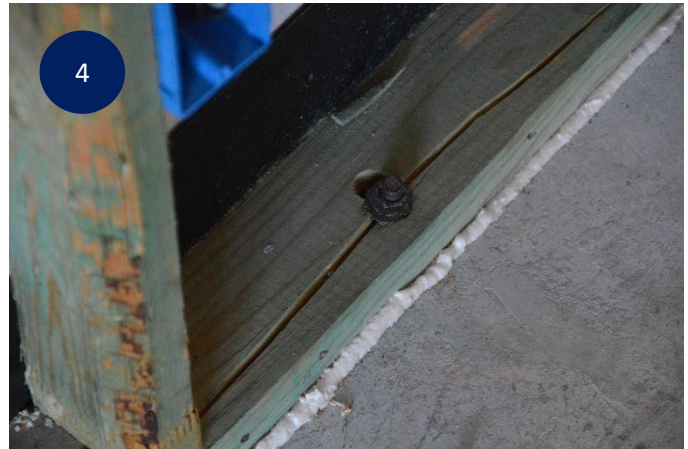
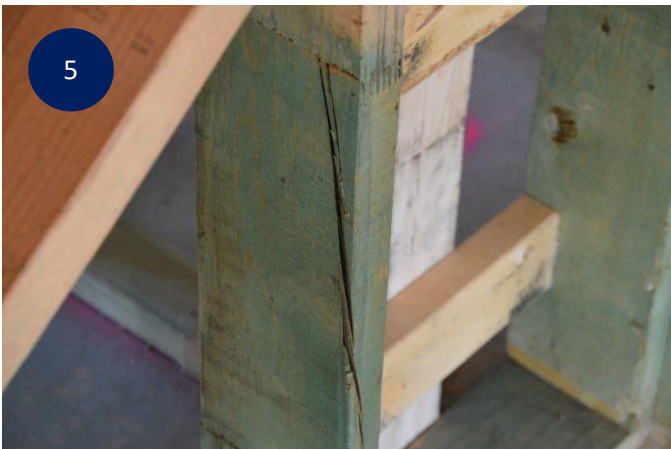
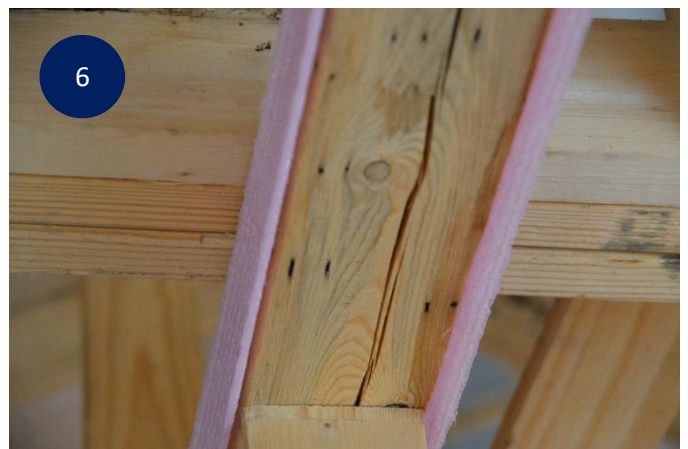
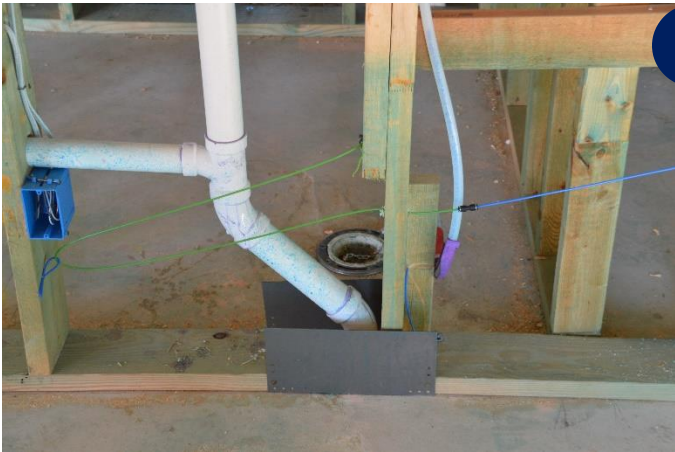
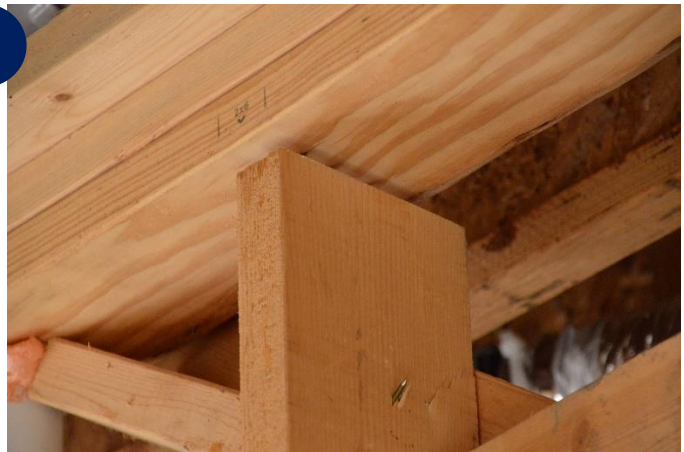
**D. Framing (interior)**

1. The studs at the front left corner of the garage door do not touch the sole plate (bottom plate). This could affect the strength of the wall and could lead to sagging.
2. The hole in the stud to the right of the kitchen sink was too large. Holes in studs can be no more than 60% of the stud width.
3. The two anchor bolt nuts need tightened at the sole plate (right of the kitchen pantry).
4. The sole plate was split at the northeast corner of the living room downstairs.
5. One of the studs along the stairs and half-bath was split.
6. The top plate was split at the upstairs master closet wall.
7. The stud by the drain vent pipe for the 1/2 bath has been cut in two and then another board nailed to it. This is ok, since it is not a load-bearing wall. However, the stud does not connect to the top plate as it should.

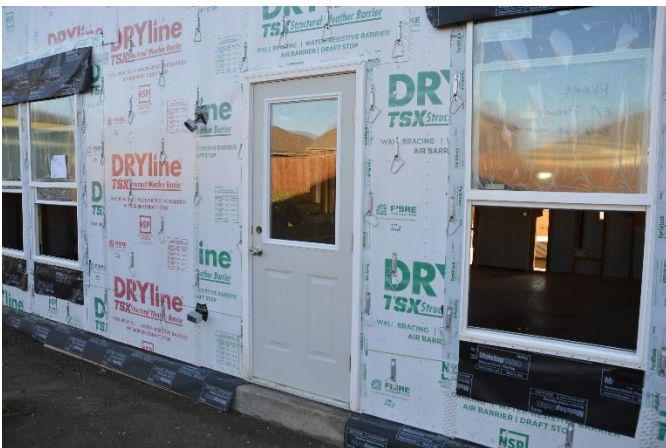
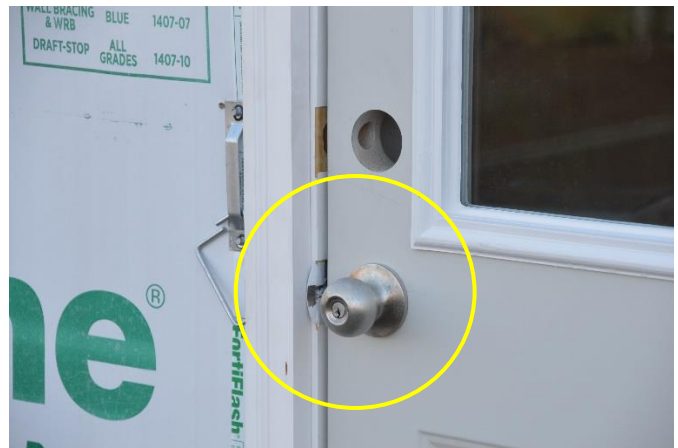
**E. Doors**

1. The back door is installed to open outward instead of into the house. This is not best or common practice.
2. Ideally, there would be a roof over the back door. Without this, rain tends to damage the door and door frame over time.

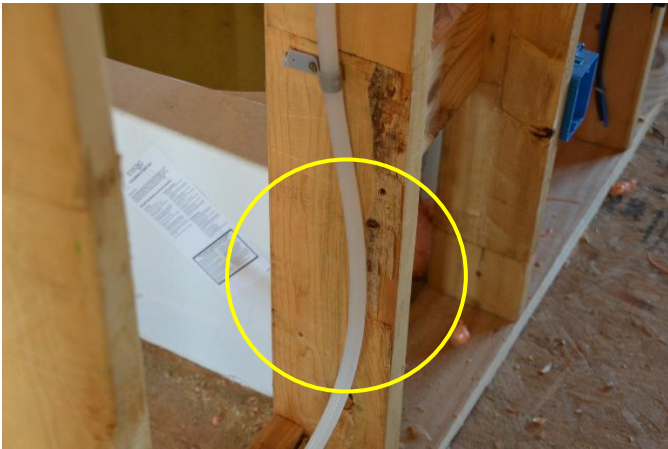
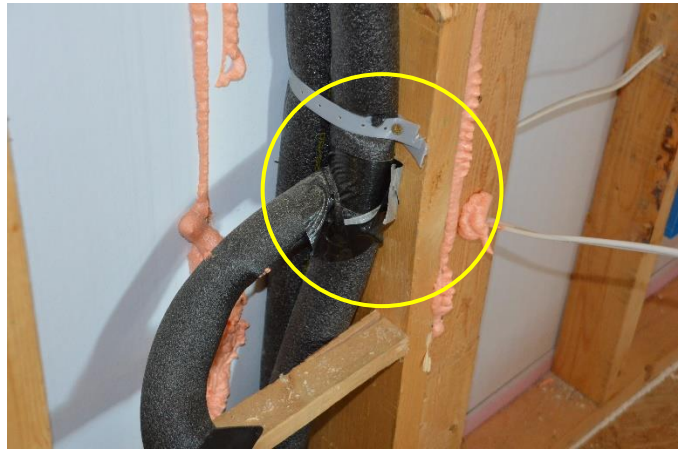
**F. Plumbing**

1. There should be protective plates over a couple of places where the plumbing lines are too close to the edge of the framing (< 1.5" to edge). I found these at the right vanity sink at the master bathroom and the supply line for the guest bathroom toilet.
