Steve Ramsey Home Inspections

December 30, 2021

PROPERTY INSPECTION REPORT

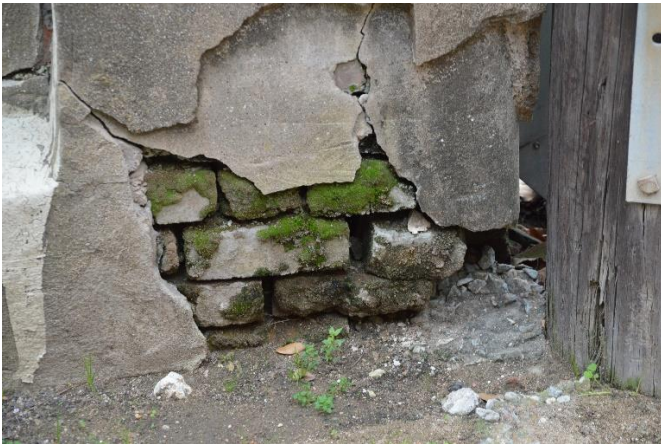
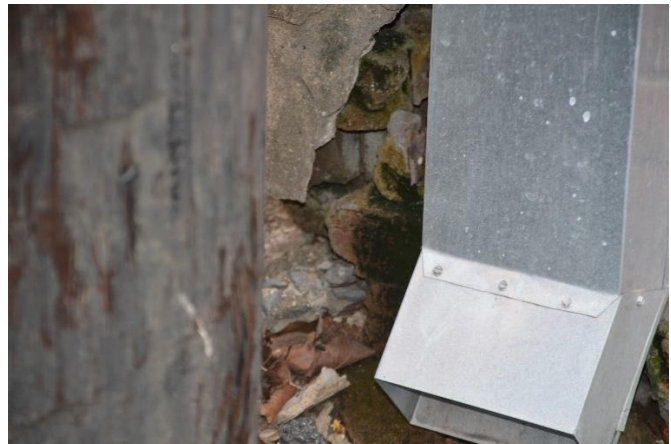
There were no signs of drainage problems for the building currently. There was some damage to the bricks at the back right corner along the ground, which might have been due to roof drainage. It appears gutters have been added to help with this. I recommend extending these slightly, however. To ensure they flow away from the foundation.

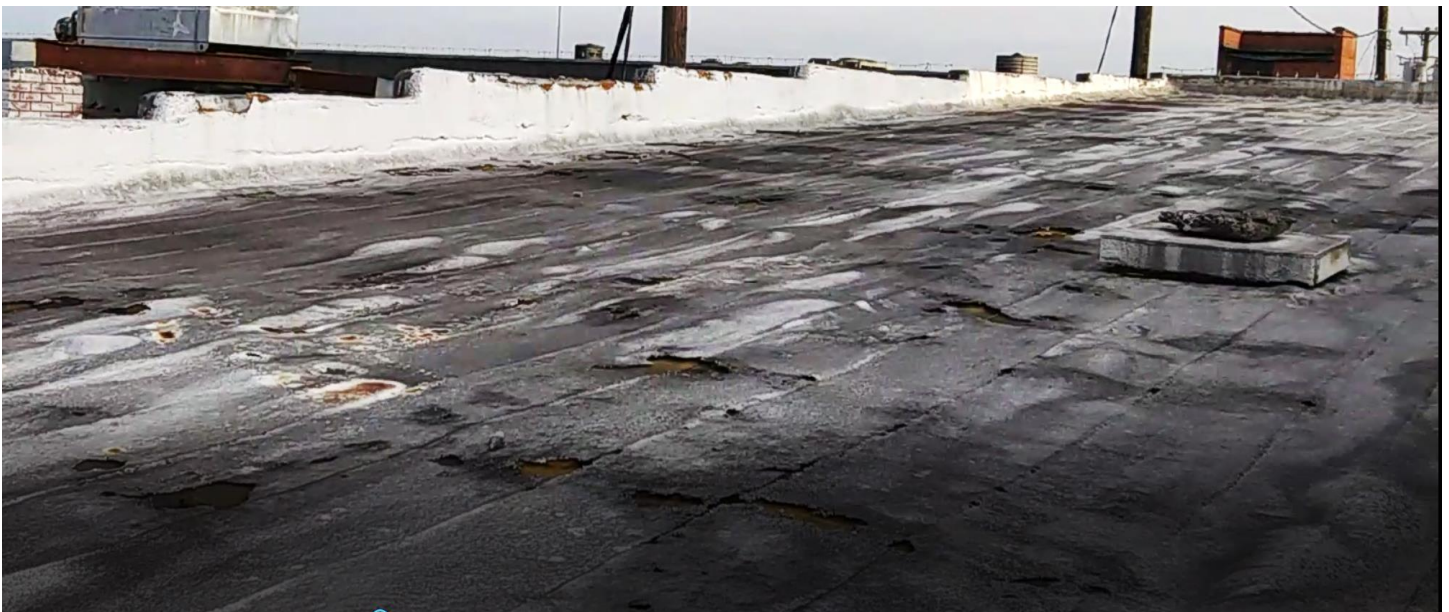
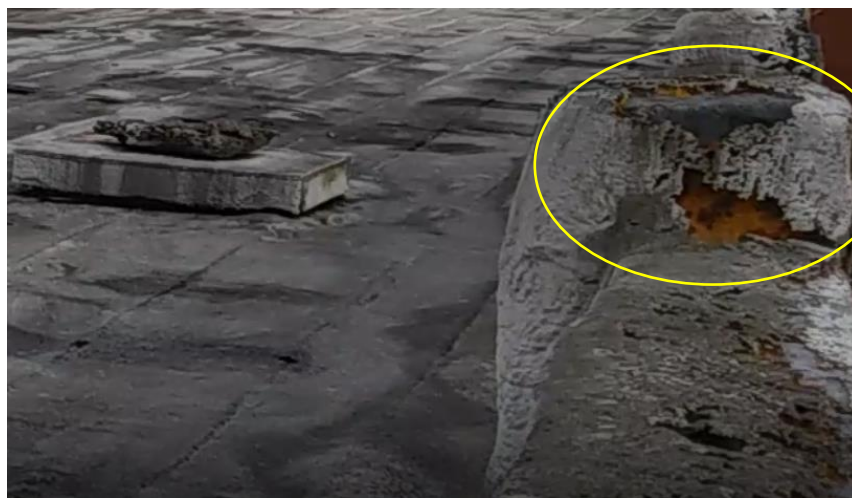
- The roof was too high for me to access with my ladder or pole, so I climbed the ladder and used a camera on a pole to take a video of the roof.
- The roof appears to have a spray foam covering the roof. This might be covering over another type of roofing, but this was not visible if present.
- The insulation covering on the roof was in poor condition in several places, with chunks of foam missing and other items. There was also a lot of waviness to the roof covering.
- To the right in the picture, there was a large box with some object sitting on it.
- There was damage along the parapet in various places as well.
- On the interior, there were no signs of water damage to the decking as best I could see.
- I recommend further inspection by a roofing professional.

Damage along parapet

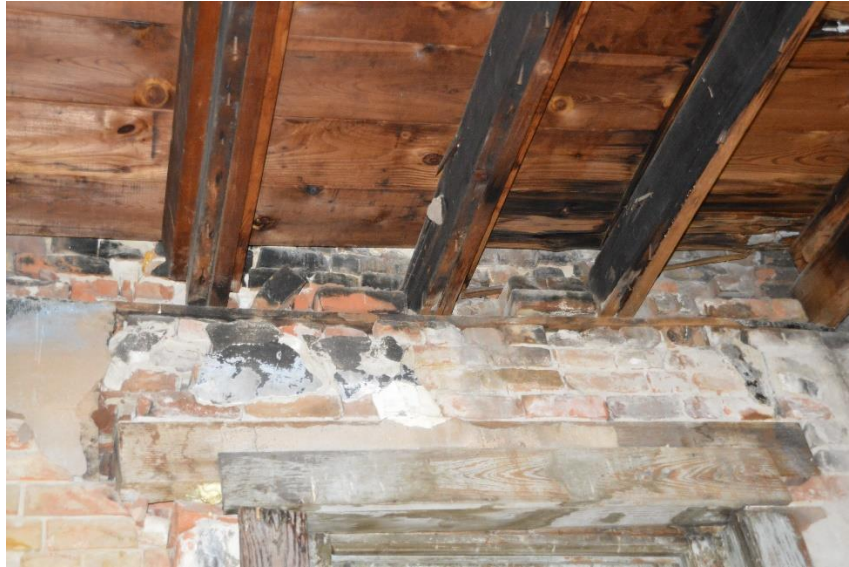
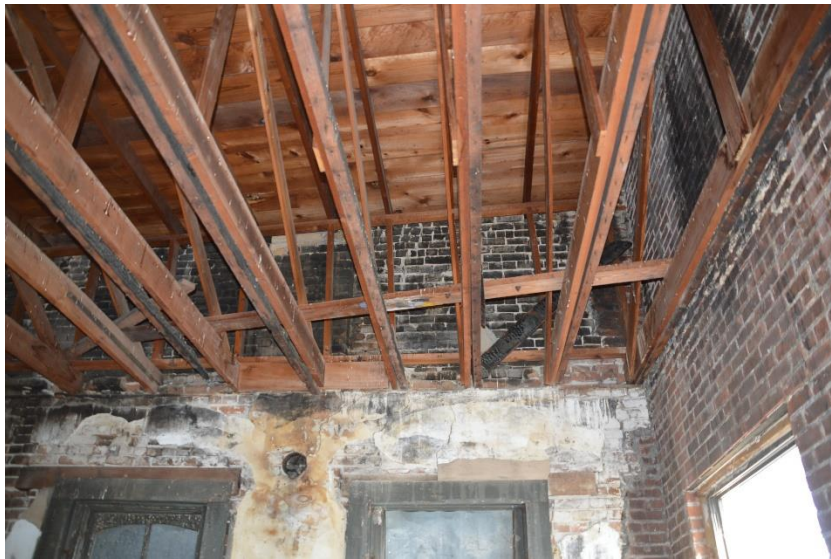
- It appears there was a fire at some point. There were several roof framing members with evidence of charring, but these appeared to have been repaired with additional boards.

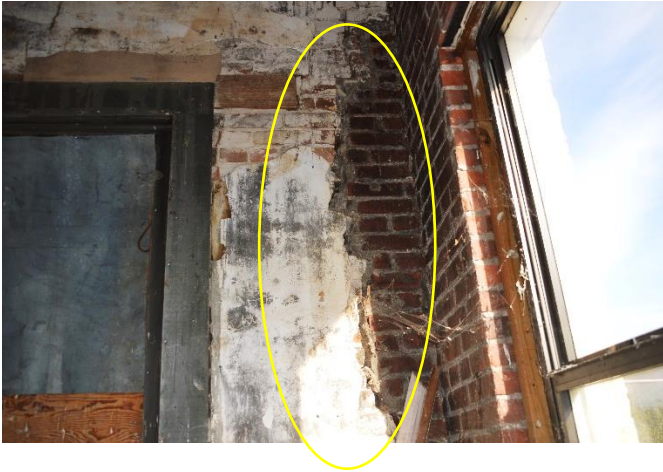
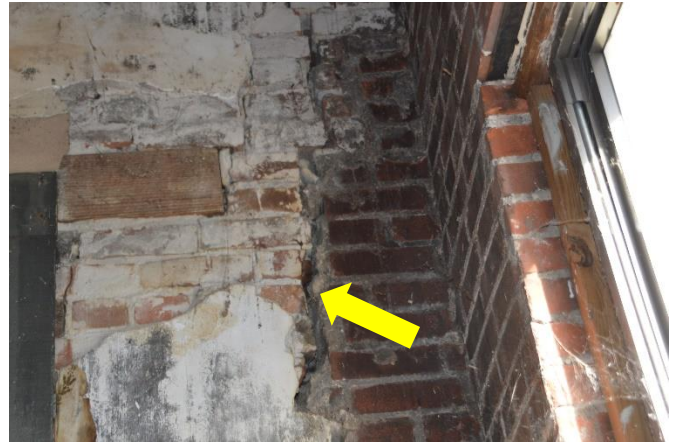
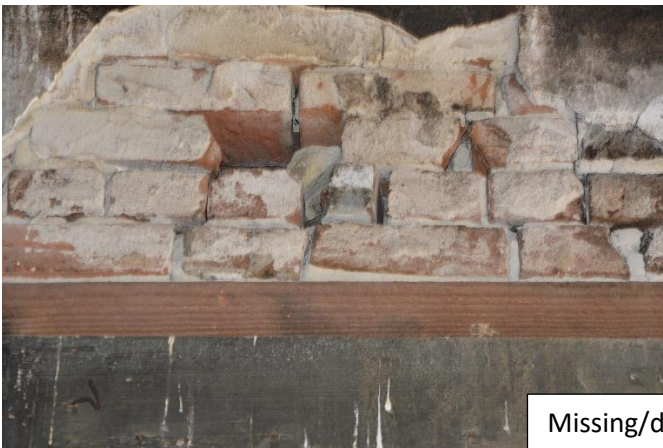
- The walls appear to be made of brick (not brick veneer, as we see on most houses).
- There was some significant movement occurring in the walls as the front right corner and the back right corner.
- At the front right, there was a gap about 1.5-2.5 inches wide. The bricks in this area have lost a lot of mortar and need to be repointed.
- At the back right, there is a large crack that is about 1-2 inches wide. This runs the length of the wall vertically, and it appears to be affecting the back right window, which is coming loose from the wall.

Missing/damaged mortar

- There were several cracks in the stucco on the bricks at the right and back areas.
- There was evidence of water damage at the interior east wall of the store. In this same area, there is a window with some missing stucco and brick around it, which might be the cause.
- The parapet wall is damaged at the front left corner. The one at the front right appears to be leaning out slightly.
- For these reasons, I recommend consulting with a structural engineer.

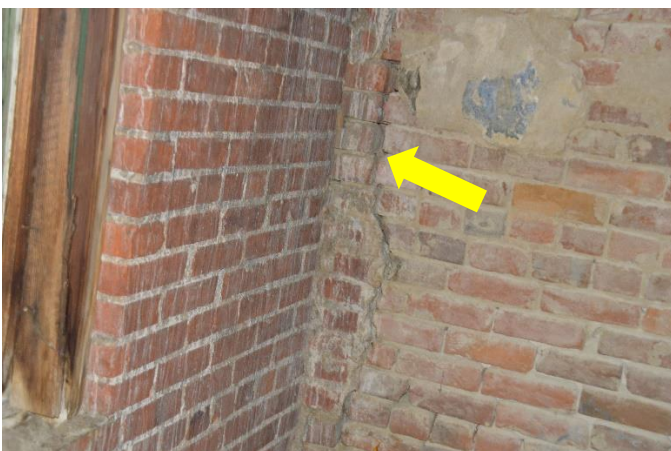
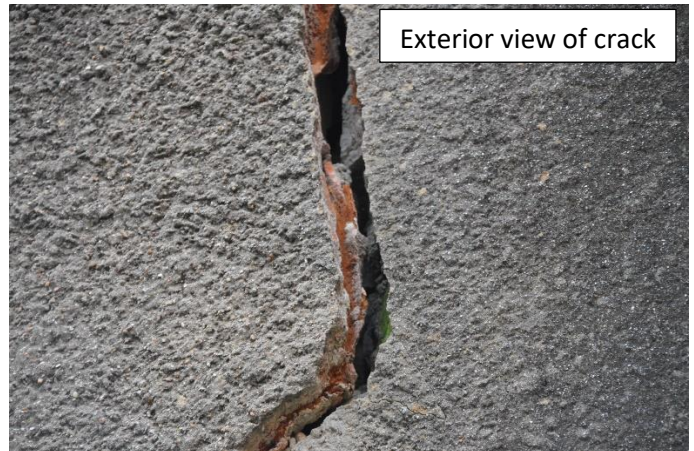
Exterior view of crack

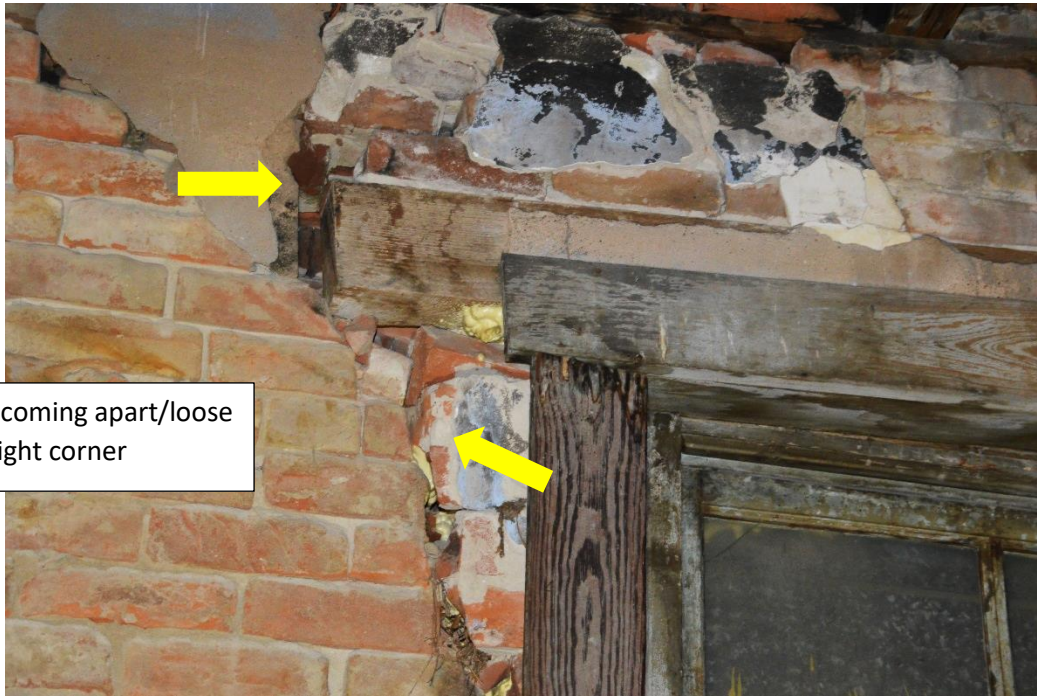
Window coming apart/loose at back right corner

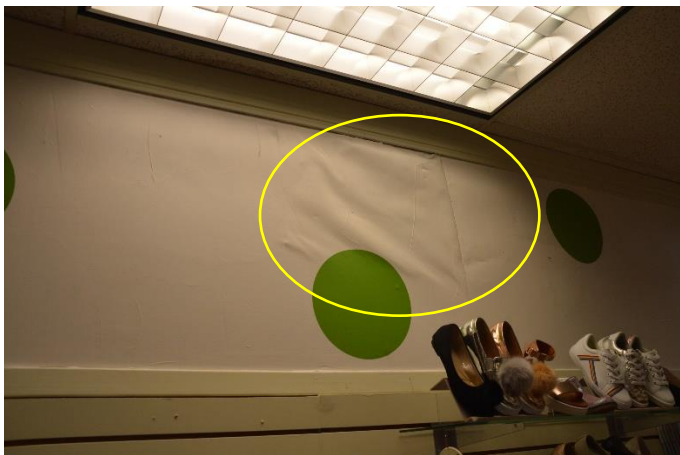
Evidence of water penetration on east interior wall

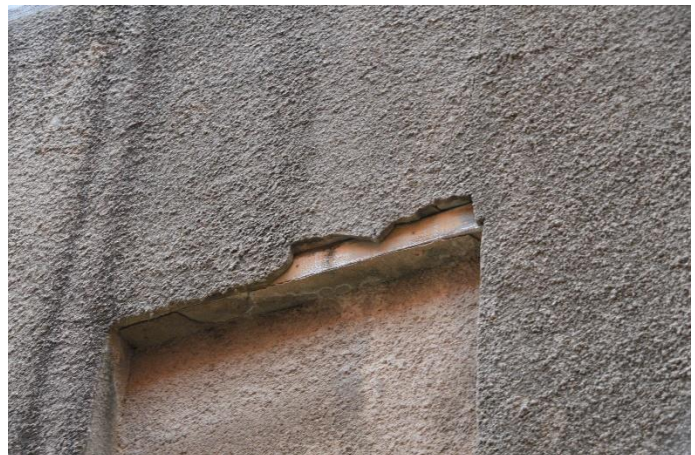
Exterior damage in same area

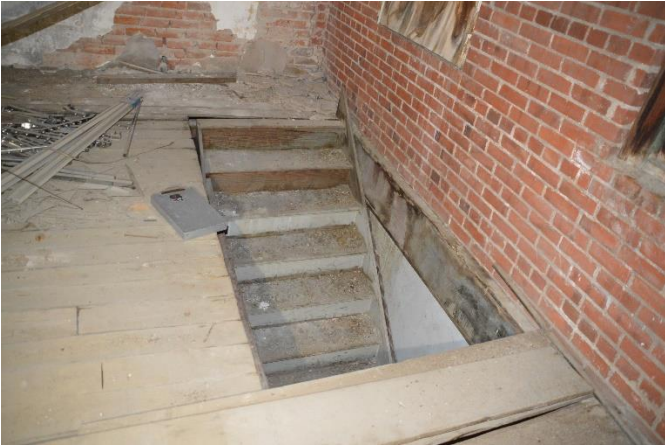
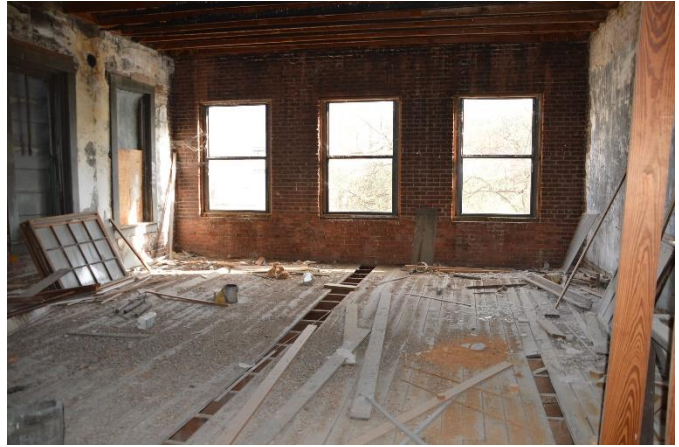
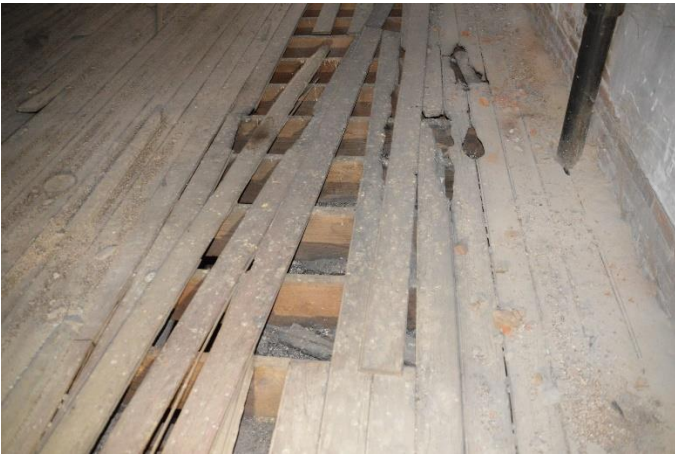
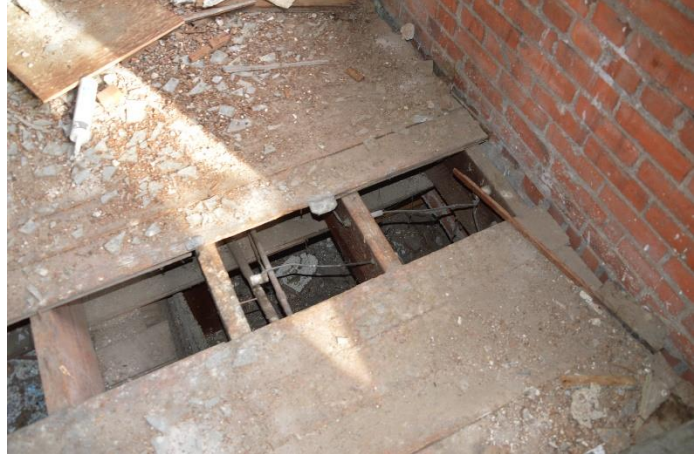
- There is no safe or good access to the upstairs portion currently. I had to remove a ceiling tile below, climb a ladder to the top of a bookcase, pull the ladder up to the top of the book case, and then get on some partial stairs.
- The flooring is buckling in places and missing in others. The majority of it, however, looks to be in fair condition.
- There were several windows that were broken or sealed off.
- There was no insulation present, except for the roof spray foam.

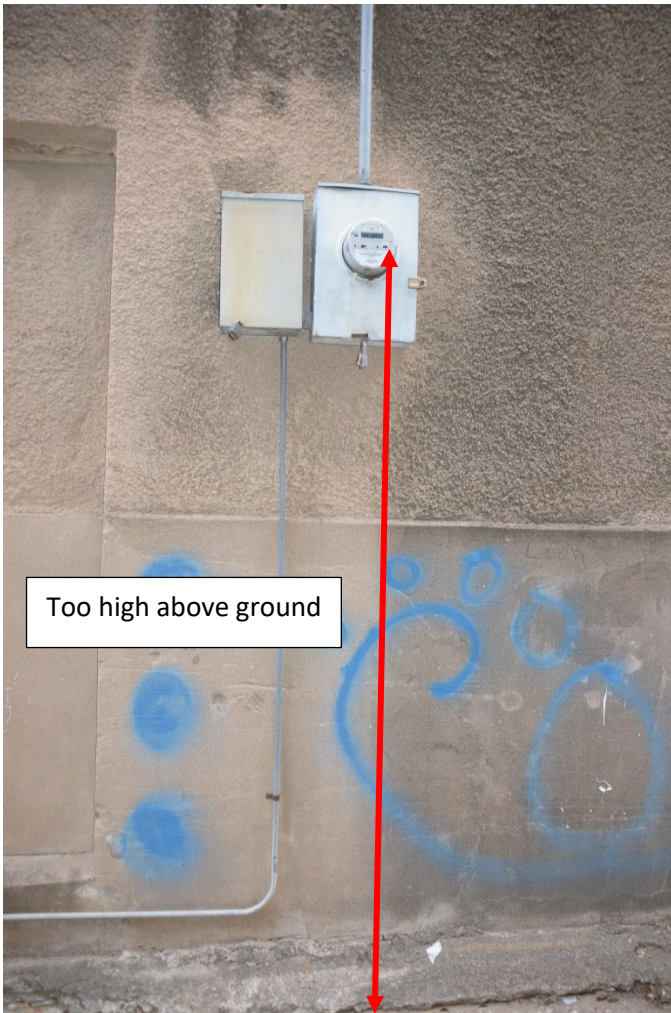
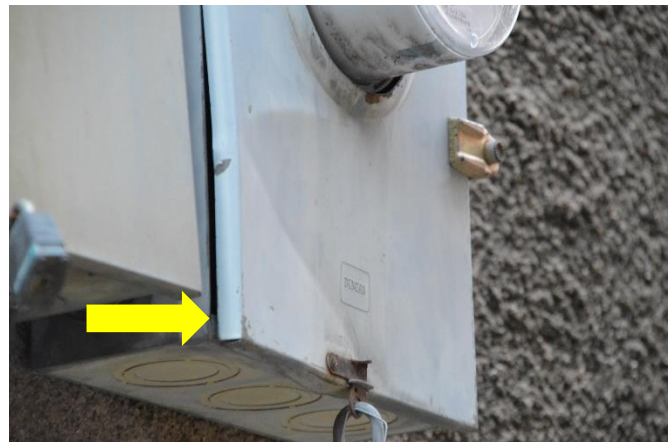
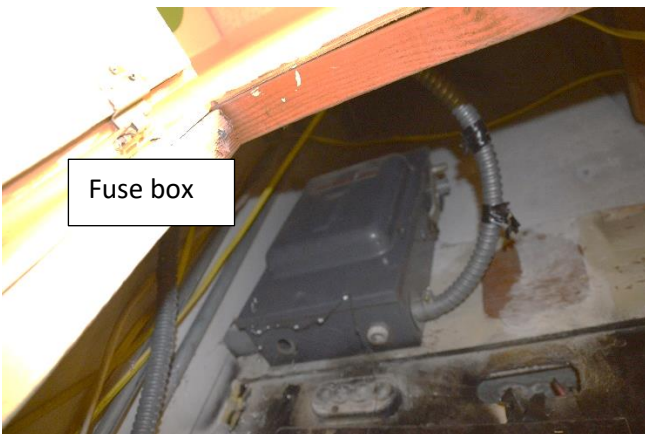
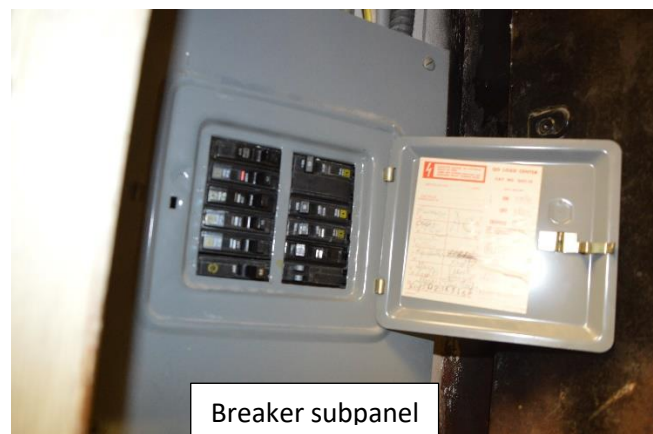
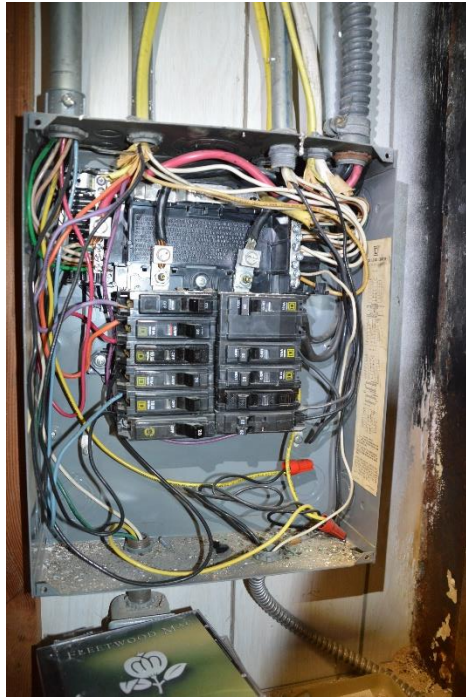
- The meter is too high. This should be between 4-6 feet above the ground.
- The meter box appears damaged at the bottom.
- I did not see a ground rod or wire.
- It looks like the main panel for the building is a fuse box in a closet at the back right of the store. This was not accessible due to its location. The wires entering the building look to be for a 100-amp service or so.

- There is a breaker subpanel in the same closet below the fuse box. This panel should have the grounds and neutral wires separated.
- Both the fuse box and breaker panel should have at least 3 feet of clearance in front and 30 inches to the side.
- I saw some knob-and-tube wire at the front in the upstairs area. I cannot determine if this is still in use or not. The wires at the breaker panel did not appear to be knob-and-tube.

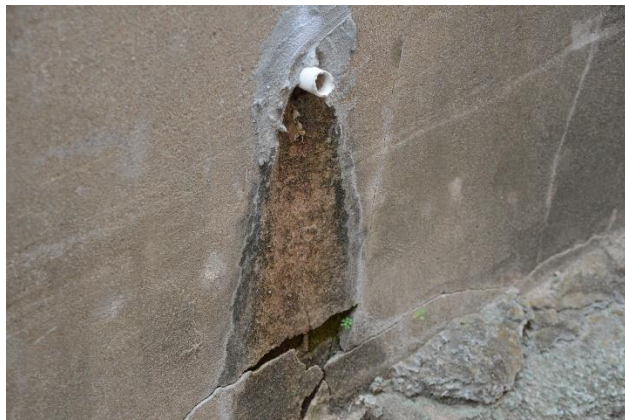
The air conditioner was operating, but the temperature differential was only 11 degrees but should be 14-22 degrees. It is a little challenging getting a good reading during this time of year, however. I could not get close enough to the condenser unit to read the label. The condensate drain needs to be extended so it does not damage the building.

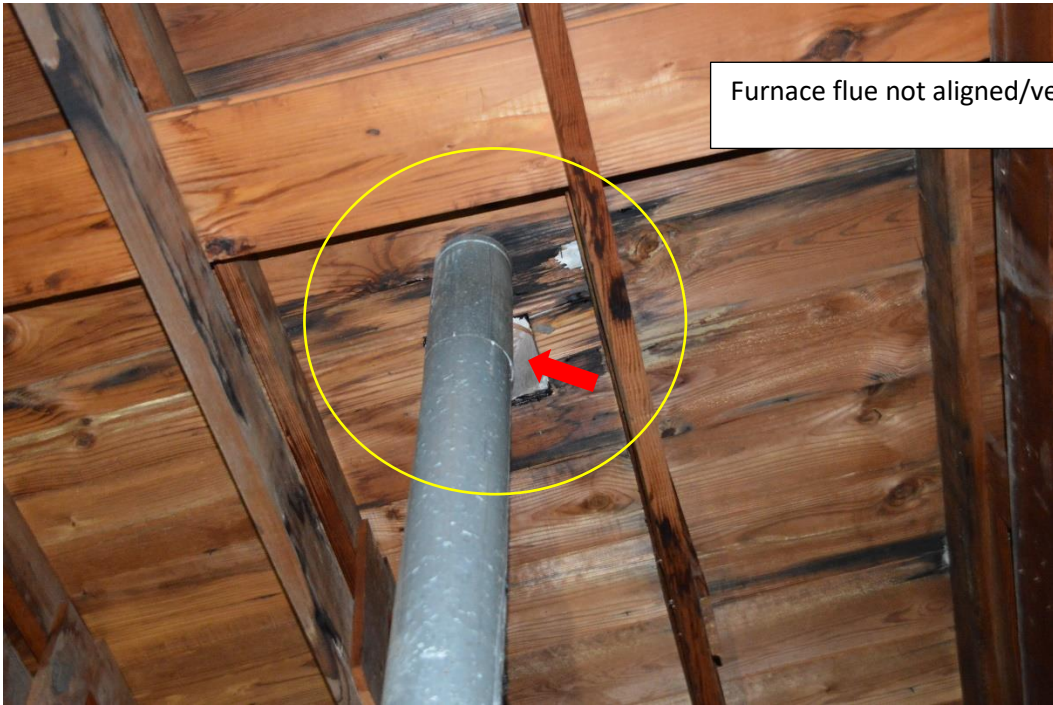
Also, the flue for the heater is loose in the upstairs and should be connected. This is a health hazard since it can pump high amounts of carbon monoxide into the area. There also should be at least 1 inch of clearance around the pipe.

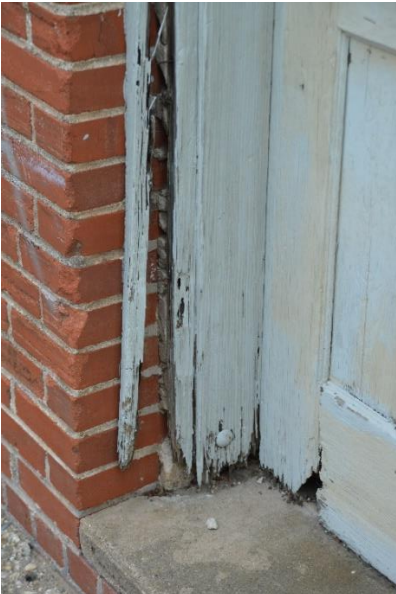
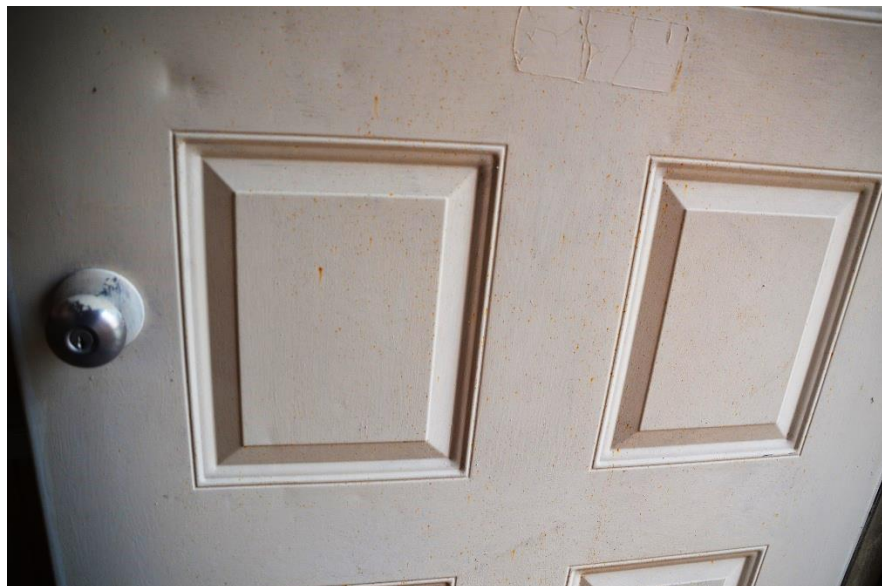
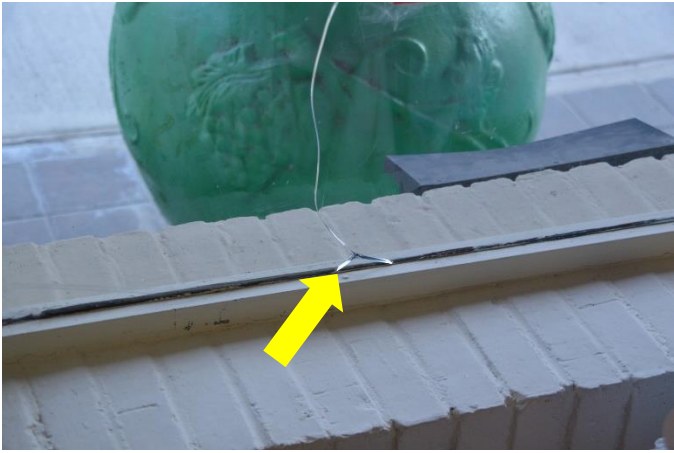
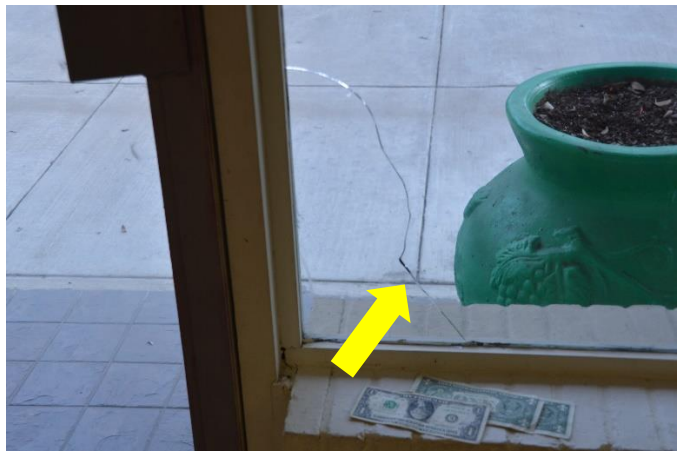
- The doors at the back were in poor condition. The frames showed excessive weathering and damage. The back door in use (metal door) was almost jammed and would only open with force. It also is starting to rust along the exterior face.
- The two plate glass windows to the left and right of the front door were cracked.
